PerfluorAd – Reference site near Danub River/D

Background

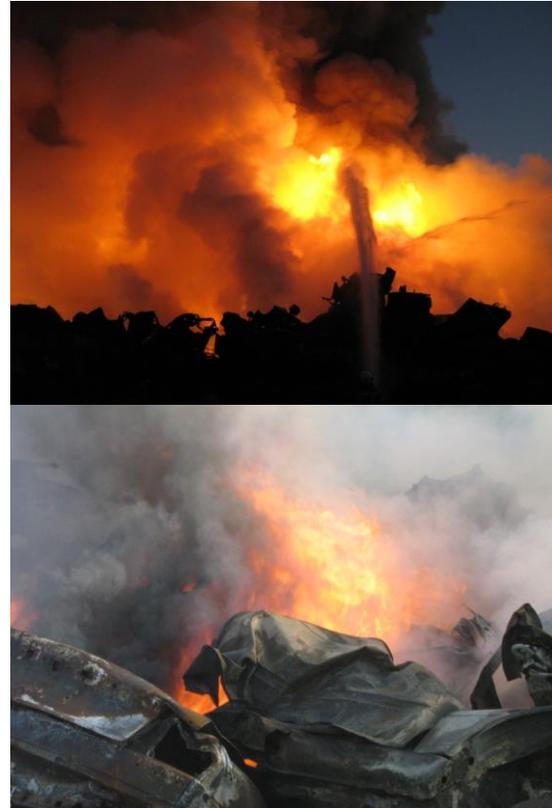
Fig. 1: Fire on that site

During the process of unloading metal waste from a railway carriage a fire had started on the metal pile which covered an area of about 30000 m². Due to the structure of that pile it was very difficult to get that fire under control. It took more than four days and it had involved about 700 members of action forces to get that fire blown out.

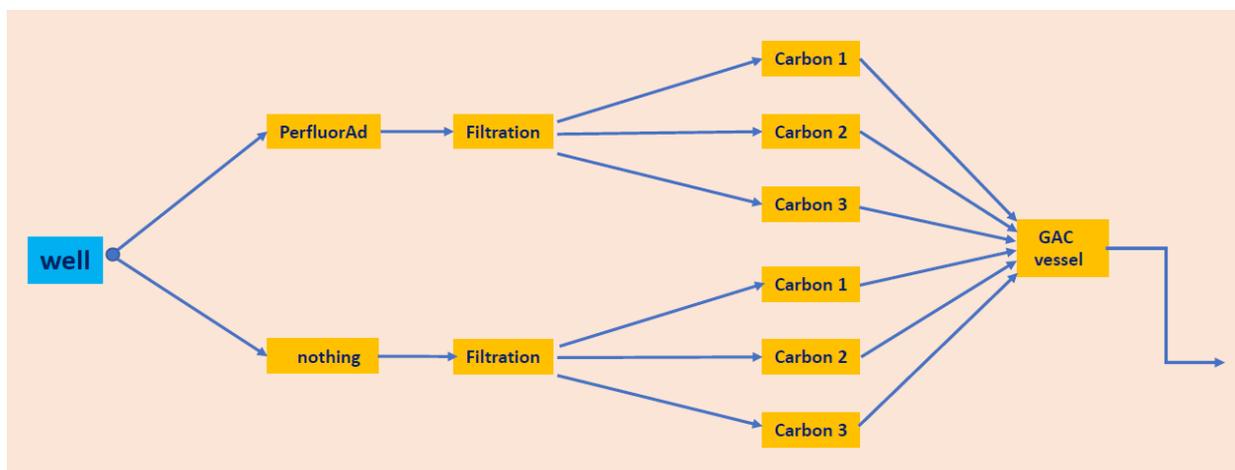
An extended field test was performed on site in 2016. During that field test, contaminated groundwater was pumped through a treatment plant at a flow rate of about 540 L/hr. The sketch below shows the configuration of that plant. Samples were taken behind the filtration and the carbon units. Three different carbon qualities got used in both lines.

Fig. 2: Technical configuration of the plant for performing the field test

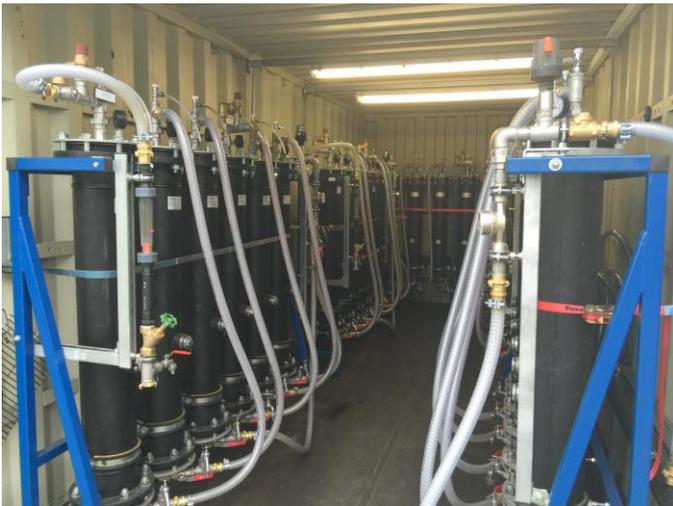
Fig. 3: Container with the carbon columns

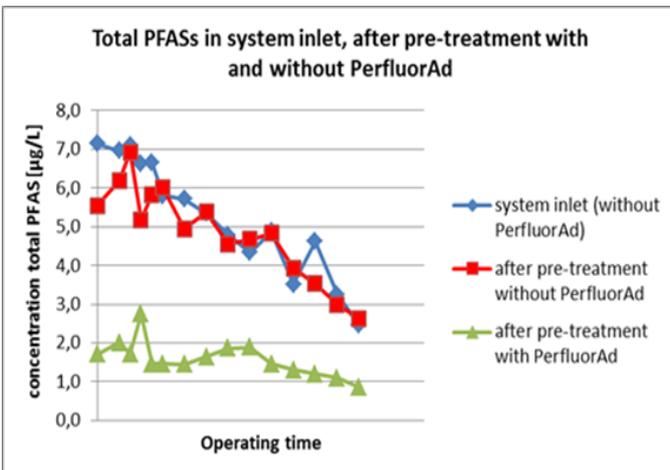
Fig. 4: PFC concentrations (inlet & filtration out)

- Decreasing concentrations of PFC (PFAS) at the inlet during the test
- In both lines carbon 2 shows better performance than carbon 1 and 3
- PerfluorAd has removed between 75% and about 65% of the PFC
- Great performance of PerfluorAd at low concentrations of PFC
- Much lower PFC concentrations at the effluent of the carbon columns in the PerfluorAd line

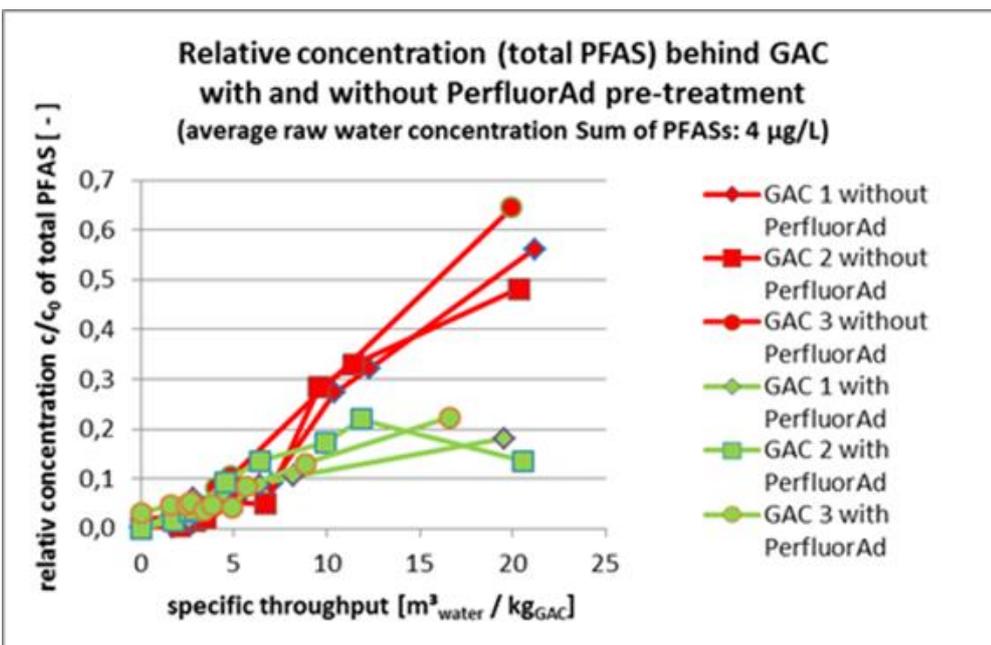
Fig. 5: PFC ratio
